# NuMI Target Hall Performance/Plans

DOE Tevatron Operations Review

March 27, 2007

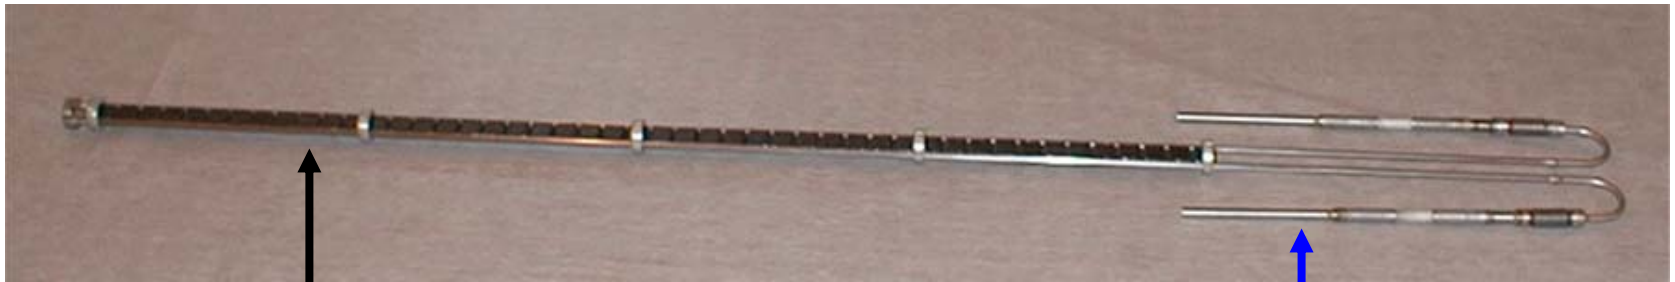
Graphite Fin Core  
6.4 mm wide

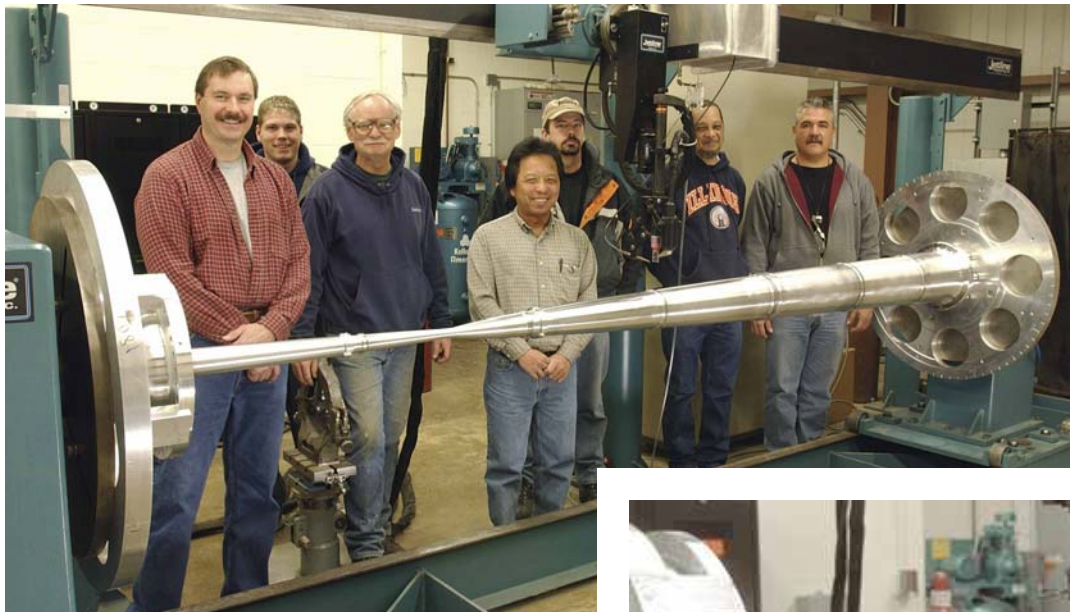
Parabolic inner conductors:  
3 Tesla max. magnetic field  
3 m active length each horn

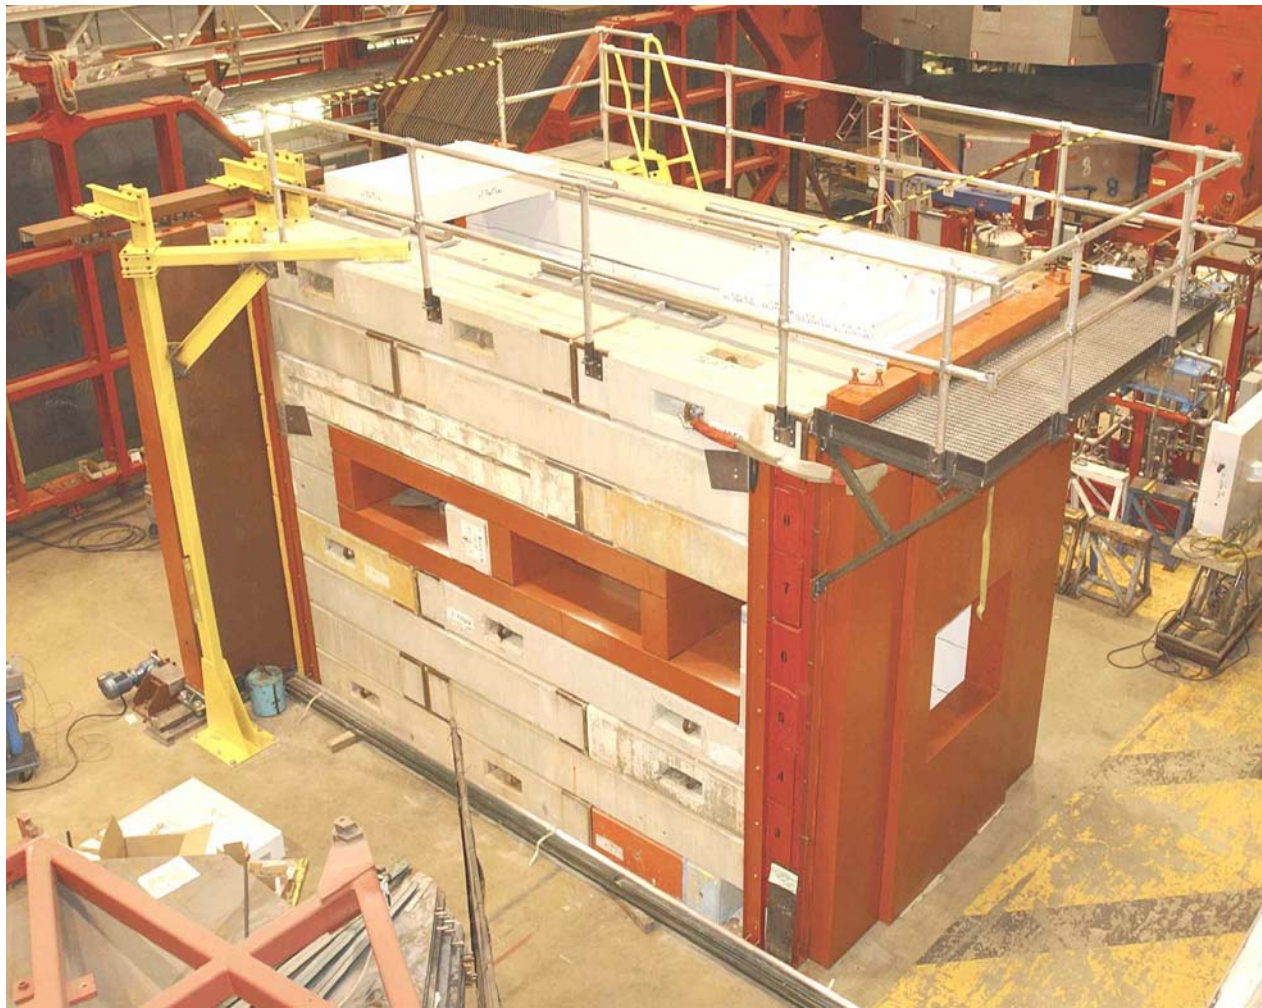
Shown during test-assembly  
above ground

Lead-glass windows (not  
shown)

Remote controlled door

Remotely installable  
top shielding

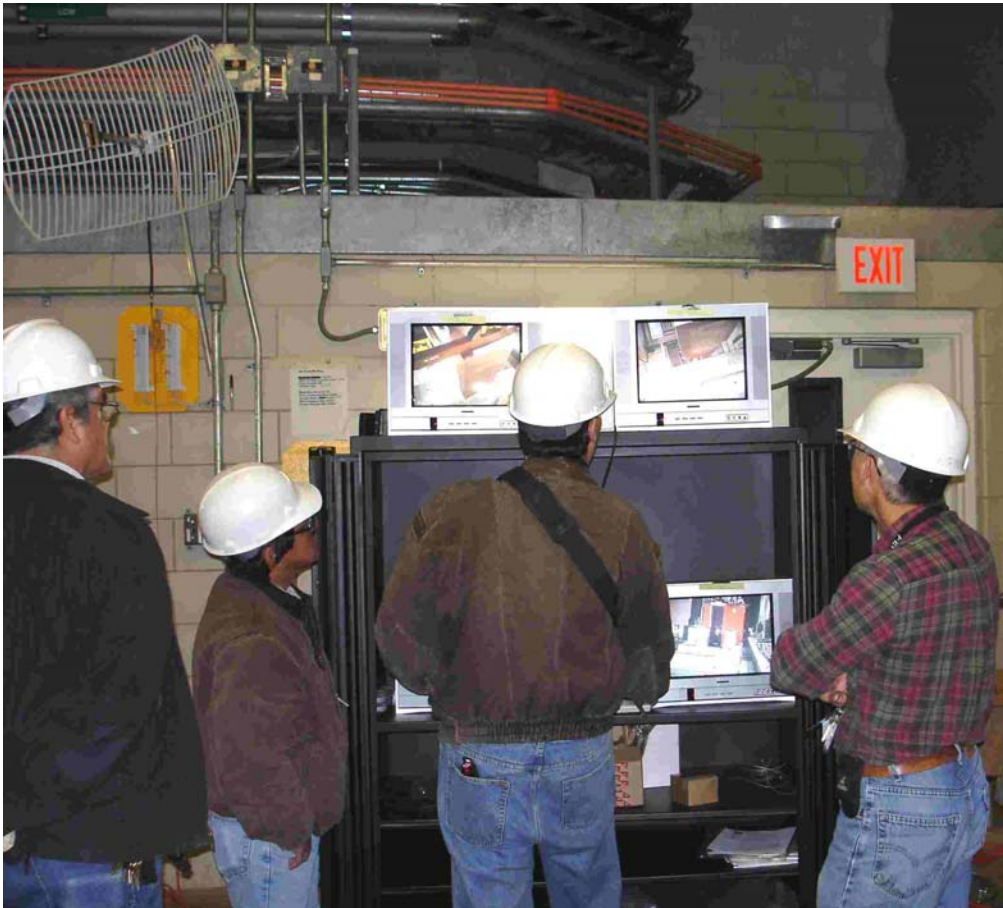
Crane includes remote hook rotation.

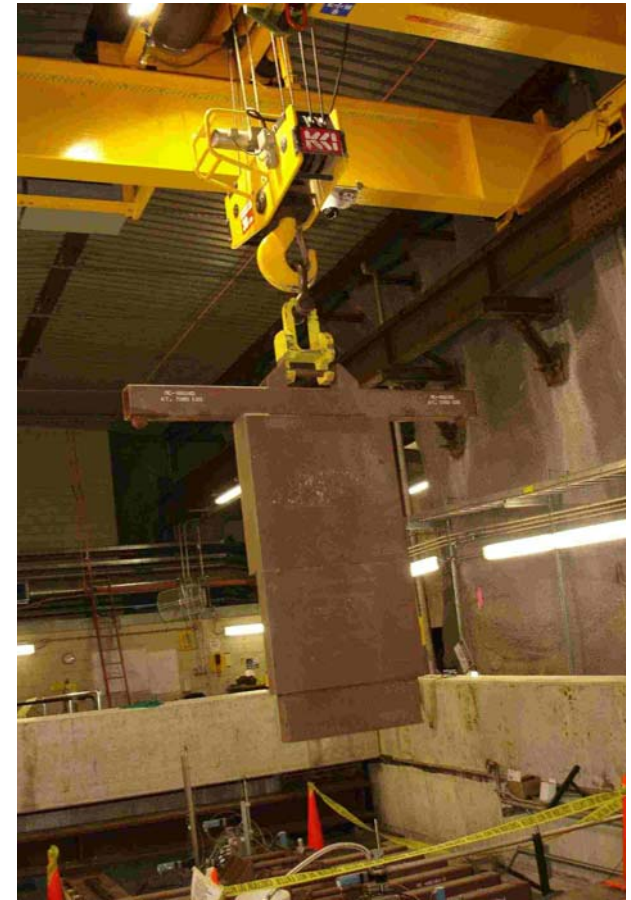
Steel shielding block being moved.

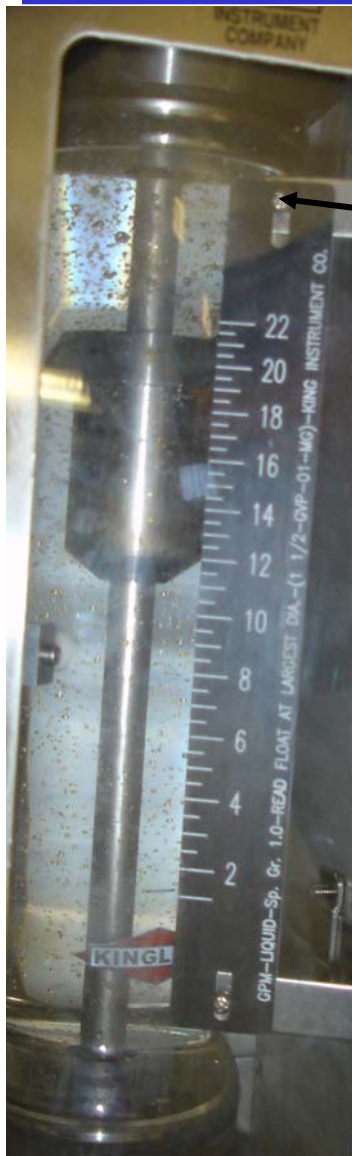
June 30, 2006, resin beads from deionization bottle clogged the water spray lines on Horn 1

Horn spray flowmeter with beads

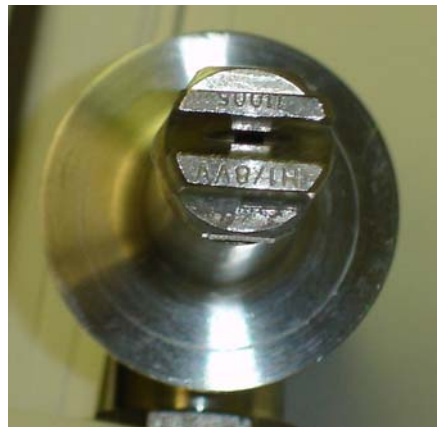
New, uncontaminated beads  
Beads are ~ 20 mils diameter

Horn nozzle for inner conductor is elliptical ~40 mils short direction (48 total)

outer conductor nozzles round, 25 mils diameter (19 total)

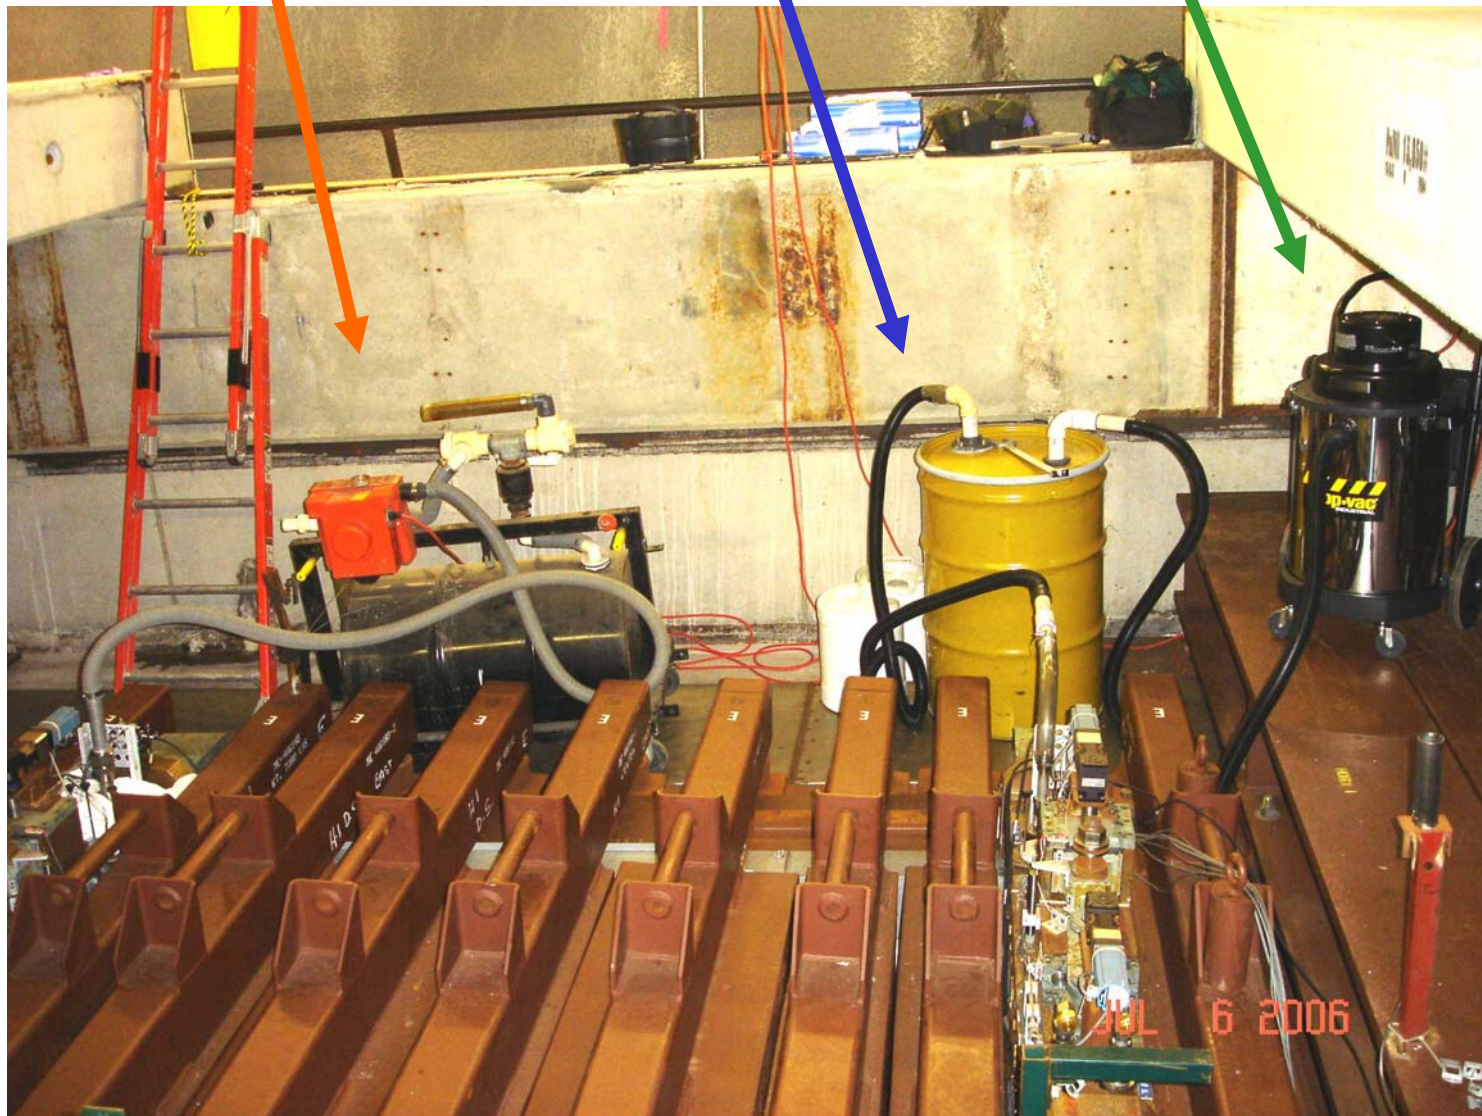
Cleaning  
Out  
Resin Beads

Fan push, water-in-barrel filter, vacuum suck

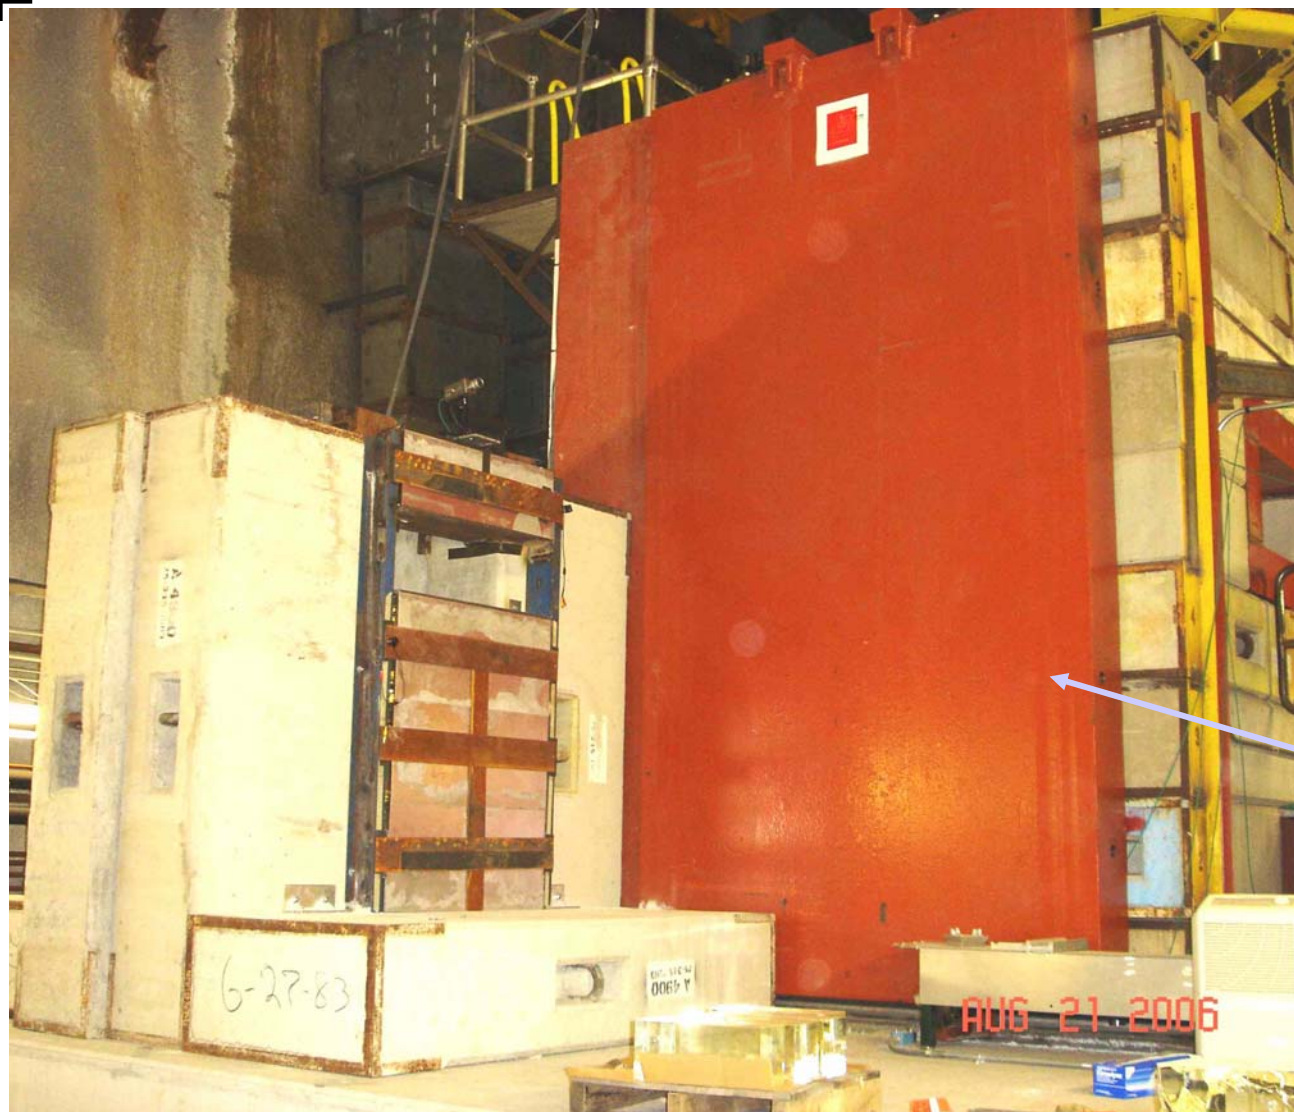
Built an extension  
of the work-cell  
with window  
for work

( Horn is in  
work-cell,  
behind the door )

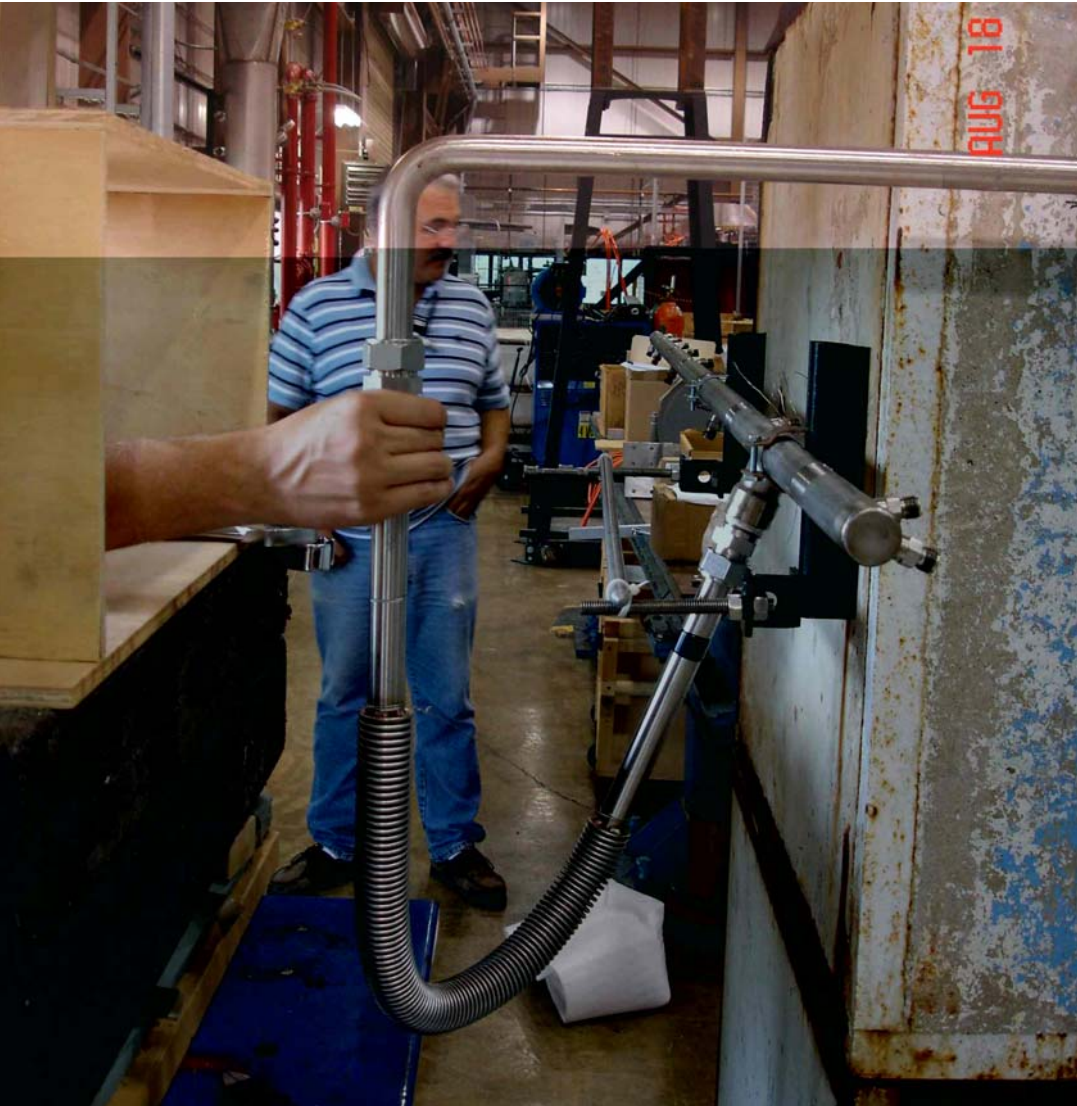
Plan, time, and practice,  
practice, practice repair

Needed to undo two  
Swagelok fittings,  
remove old section,  
insert new section,  
and tighten two fittings.

Time est: 2 min. of  
actual work in slot

Dose for this "2 min." job  
was 371 mr, (3.7 mSv)  
divided over ~10 people.

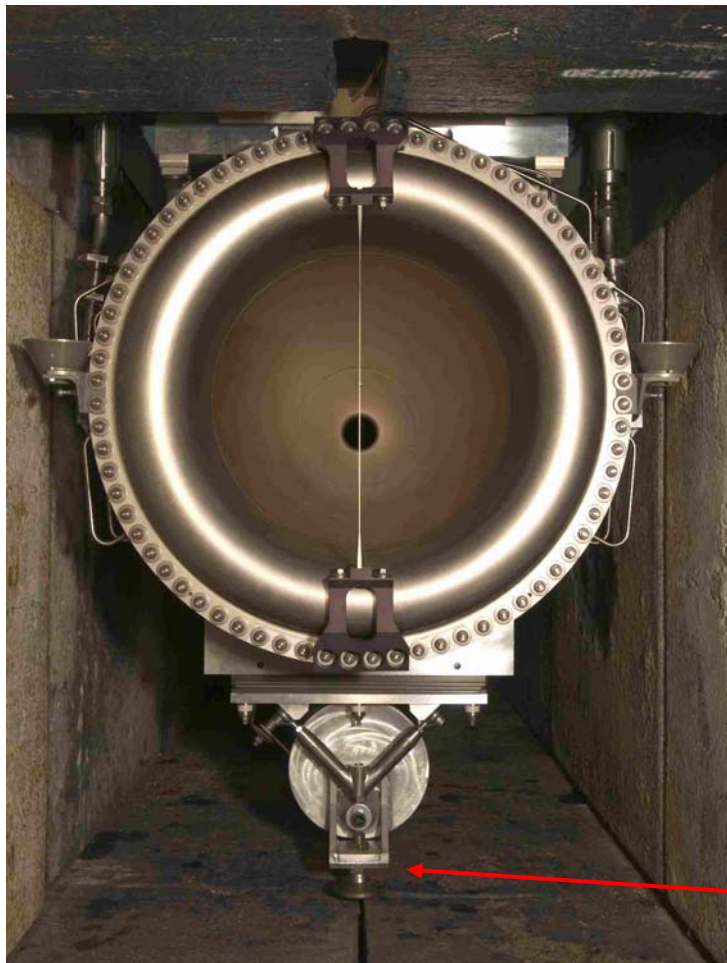
Horn 2 before beam  
*1.5 inch clearance foot to floor*

Owl shift Thurs. Sept. 29, 2005 intermittent horn trips.  
Owl shift Sat. Oct. 1, hard ground fault of 1 ohm.  
*-removing stripline fingers Horn 2 + stripline block  
-when Horn 2 moved to work cell ground fault cleared  
-foot left behind in chase, nut had vibrated off  
-scorch marks seen under foot*

Moved old foot, installed new foot
